## G-MOPF 2018: Warning message "Water fording not possible"

| Topic number | LI09.00-P-074794 |
| Validity | Model 463.260/261/276/277 MOPF with modification year 19 (code XZ9), modification year 20 (code X20) or modification year 20/3 (code ZX9) |

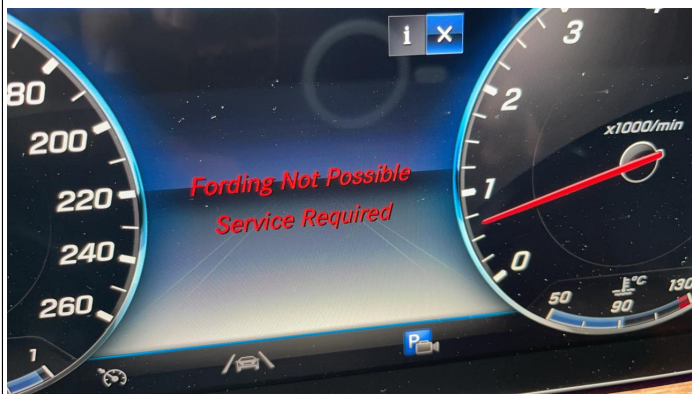
| Attachments | |
|---|---|
| <a href="#">Fehlermeldung Englisch.jpg</a> | Fault message in instrument cluster (English) |

Customer reports a warning message in red in the instrument cluster: "Water fording not possible! Service required". The message is no longer active following an ignition cycle.

As a result of an absent or aborted reference run of the air flaps of the N127 'drivetrain' control unit (PTCU), the fault codes P153001 and P153101 are stored in the fault memory and the "Water fording not possible" warning message appears in the instrument cluster. The flap system nevertheless functions correctly.

1. Perform software update of the N127 'powertrain' control unit (PTCU) (XENTRY data status 12/2021 or more recent)
2. Check function of air flaps M108/1 and M108/2 through actuation

3. Check actual values of fording depth sensor B168 (specified value 4.60 V ± 0.2 V)
