IPC-9121

Troubleshooting for Printed Board Fabrication Processes

Developed by the Printed Board Process Effects Handbook
Subcommittee (7-24) of the Process Control Management
Committee (7-20) of IPC

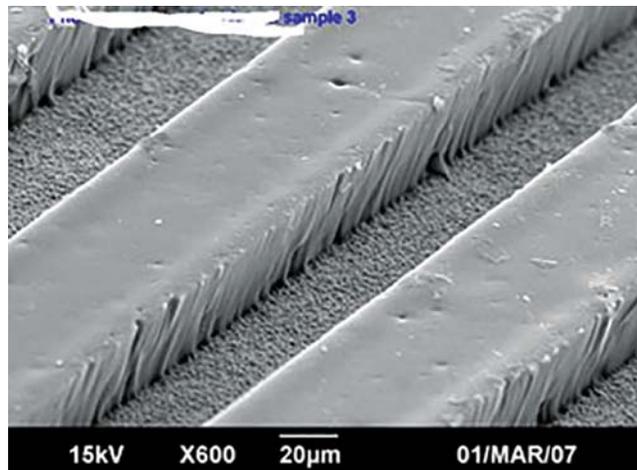
Figure 1-1

Issue: Photoresist under-exposure

CAUSE	ACTION
UV source inadequate	Check exposure intensity/wavelength/duration
Expose intensity inadequate	Review, reinstated exposure control procedures
Expose time inadequate	Review, reinstated exposure control procedures
Oxygen exposure of photoresist prior to exposure	Review photoresist shelf life
Potential test methods (discover)	Potential test method (verification)
AOI (line/space reproduction) Etch-outs	AOI Periodic UV photometer and step tablet exposure checks
